NEW DRIVE MECHANISM IN COLD AREA WITH ECO-WHISPER MODE

The drive mechanism is extremely quiet and intelligently located in the cooler, lower section of the ECOS

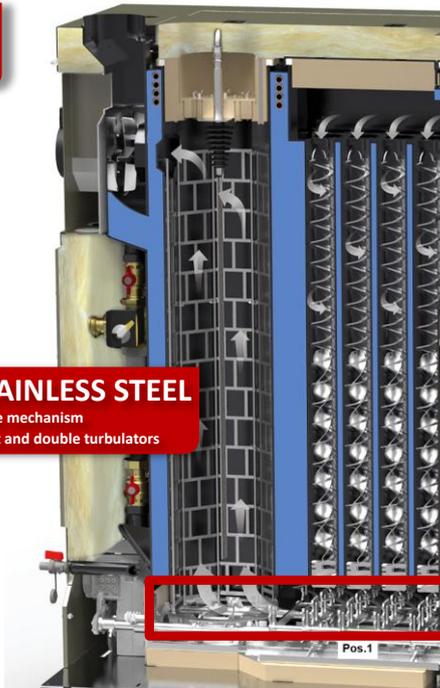
Mechanism below, with ECO whisper mode!

The mechanics of the heating system are located in the lower or cooler area of the system (e.g. heat exchanger cleaning mechanism, drive mechanism for sliding floor, mechanism for E-filter cleaning basket and drive shafts). It runs in **ECO** whisper mode!

Due to the mounting brackets (**pos. 1**) in the lower, cooler area, the spiral automatically rotates into the mounting brackets under its own weight when the respective spring turbulator incl. the spiral turbulator (double turbulator) is mounted and is thus fixed and secured. This means that there is no need for a lateral opening of the water-flushed outer wall, which would reduce the heat exchanger surface and thus its performance

Drive mechanism is not exposed to high temperatures (thermal load extremely low)

Wear on mechanical parts is reduced many times over!

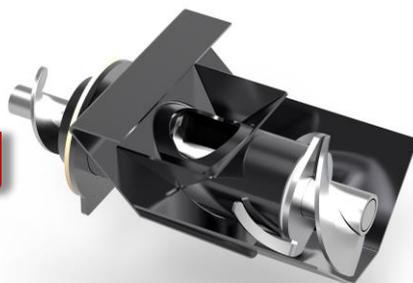
The self-developed transition screw has an integrated counter-run, which seals the screw

With the transition screw, the ash from the heat exchanger is brought together with the ash from the combustion chamber, but reliably seals the two areas from each other.

Transition screw with integrated counter-rotating screw, which seals 100%
